## MICROMETEOROID IMPACTS ON THE HUBBLE SPACE TELESCOPE WIDE FIELD AND PLANETARY CAMERA 2: ION BEAM ANALYSIS OF SUBTLE IMPACTOR TRACES.

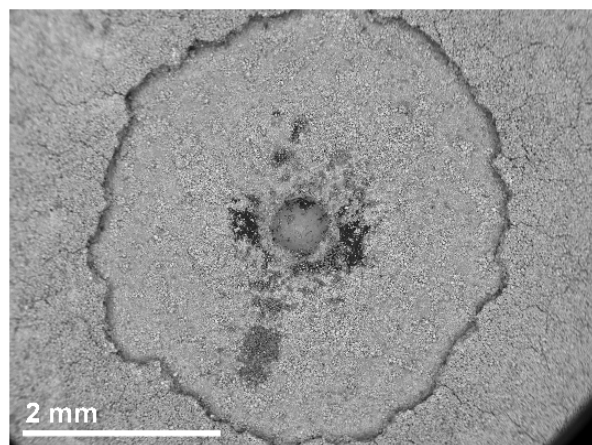
Fig. 1. Impact feature 462, on a core cut from the surface of the WFPC2 radiator shield, backscattered electron image (BEI). Note the large area of paint loss around a central bowl-shaped pit in underlying alloy.

**Results:** 4 test samples and 32 impacts were analysed by PIXE in this study, WFPC2-462 (Fig. 1) is a good example. SEM-EDX of the pit surface had shown enrichment of Mg, Si and Fe above alloy composition (Fig. 2a and b), but was unable to detect other elements that might indicate whether this MM was only silicate, or might also contain sulfide or metal components.

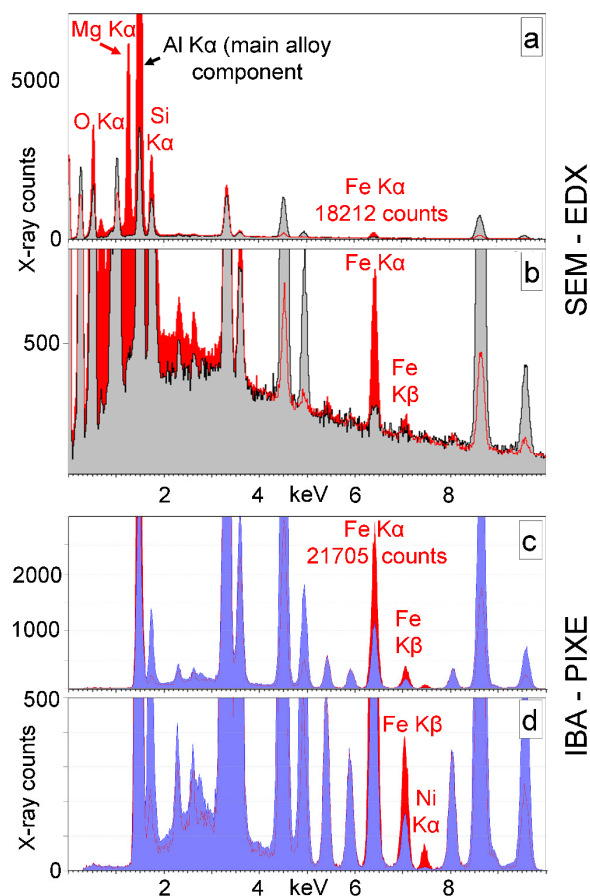
Fig. 2. WFPC2 sample 462: a) and b) SEM-EDX spectrum of metal in pit (red) compared to surrounding metal (grey); c) and d) PIXE spectrum of metal area inside pit (red) compared to surrounding metal (blue). The SEM-EDX spectra are normalized to the background between Cr K $\alpha$  and Cr K $\beta$ . The PIXE spectra are normalized to the Cr K $\alpha$  peak area.

Acquisition of PIXE data from the central area of the impact allowed elemental maps and spectra to be extracted from: specific areas on the surface of the melt pit; and the metal alloy (where exhumed by spallation of the paint layer). Comparison of the spectra revealed not only enrichment of Fe (Fig 2c, also seen in the earlier SEM-EDX spectra 2a and b), but also nickel (Fig. 2d). The extracted Ni map (Fig. 3) shows localisation within the melt pit. Coincidence with Fe distribution strongly suggests a second MM material is present, probably Fe+Ni metal, possibly a remnant of kamacite.

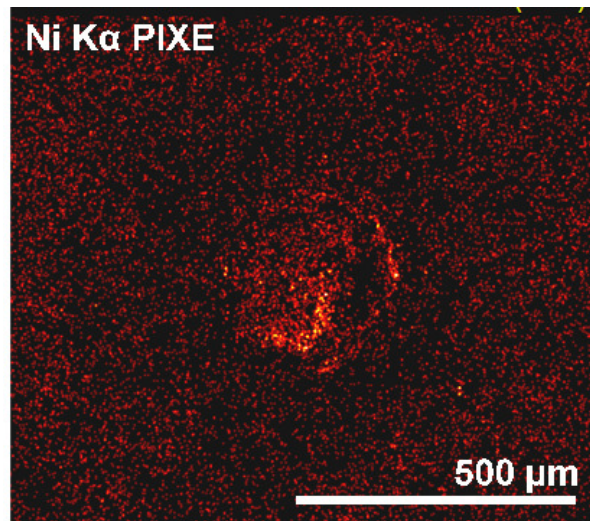
Fig. 3. WFPC2 sample 462: PIXE map of nickel distribution across the central pit.

**Discussion and conclusions:** Success of IBA in finding very low concentration impactor signatures is due to the nature of particle interactions involved. On entering a sample, SEM beam electrons lose energy by X-ray emission, creating a distinctive background (e.g. Fig. 3b). Where channel by channel variation is high (especially in short data collection), this background may have a ‘ragged’ appearance. Because a characteristic X-ray line peak area must reach 3 times background variation (sigma) for positive identification as above detection limit, in ‘noisy’ SEM-EDX spectra small X-ray peaks may fail to be recognized. Even with long collection times (e.g. 200 secs [3]), although the background becomes much smoother (sigma reduced as a proportion of peak area), it does still limit determination of elements to > 0.05 wt %. However, irradiation with an energetic beam of protons, as in PIXE, does not generate an appreciable X-ray background (Fig. 2c and d), and even very low count rates at characteristic energies can be recognized and quantified. (PIXE) is thus a much more sensitive technique, especially for trace analysis of transition metals [6], and can reveal subtle impactor traces, invisible to SEM-EDX.
